FULL RESERVE STUDY

Beechwood Shores Homeowners Association

Moneta, Virginia

May 4, 2021

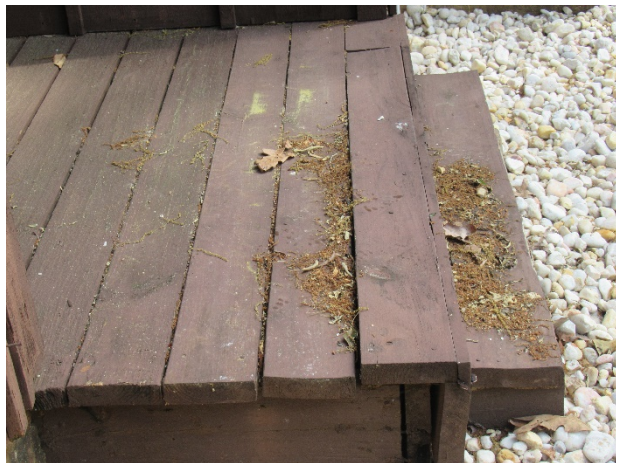
Condition: The decks are in good to fair overall condition with warped components evident. The screens are in good to fair overall condition

Wood deflection

Useful Life: Wood decks last 15- to 25-years with proper maintenance; we recommend interim replacement of the deck boards be funded through the operating budget. The rates and types of deterioration are not uniform due to the nature of wood. Replacement

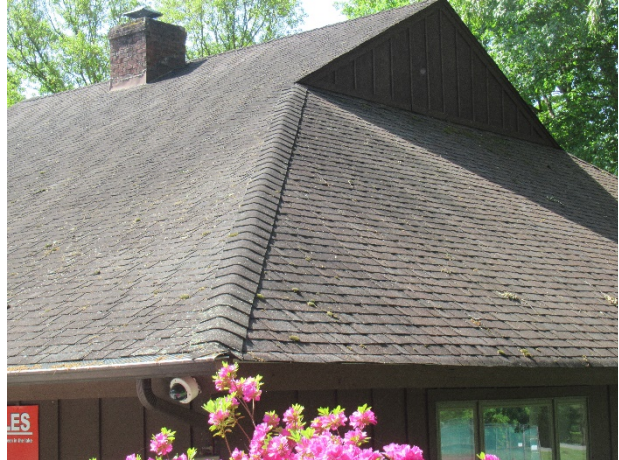
Condition: Fair to poor overall with shingle lift and organic growth shingles evident from our visual inspection from the ground. The Board does not report a history of leaks.

Clubhouse roof overview – Note: organic growth

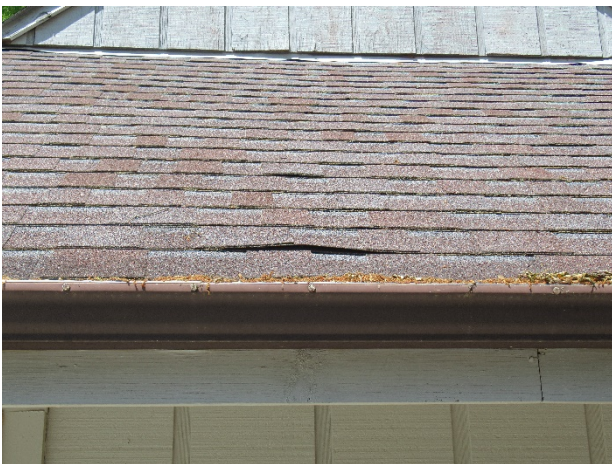
Pool house shingle lift

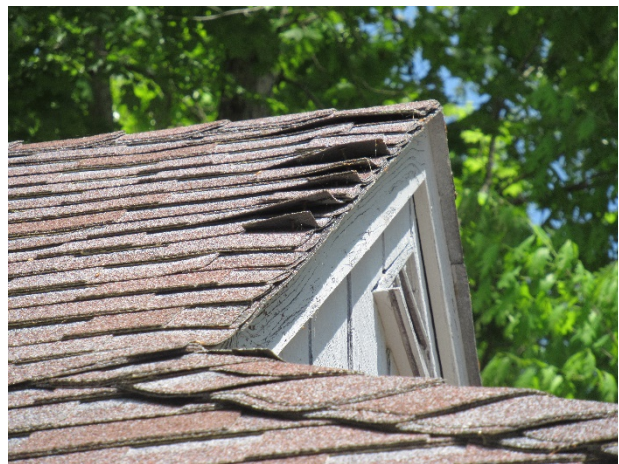
Pool house shingle lift

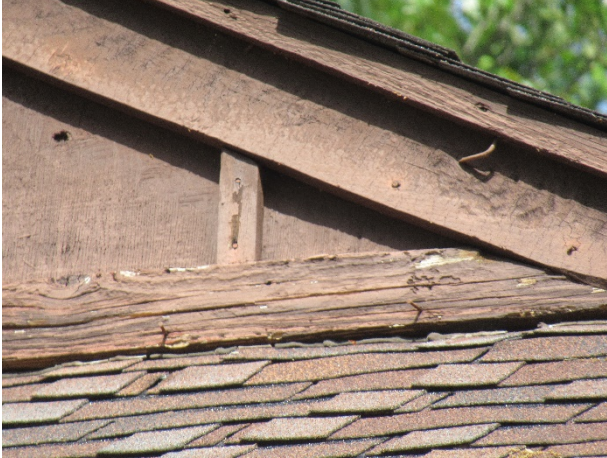
Condition: Fair overall with faded and chipped paint evident

Wood trim deterioration

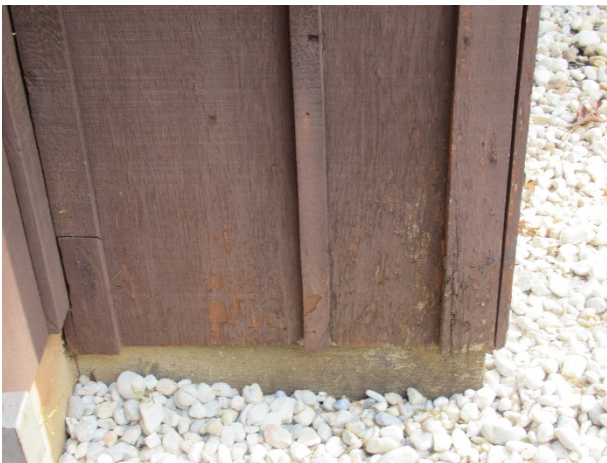
Wood siding finish deterioration

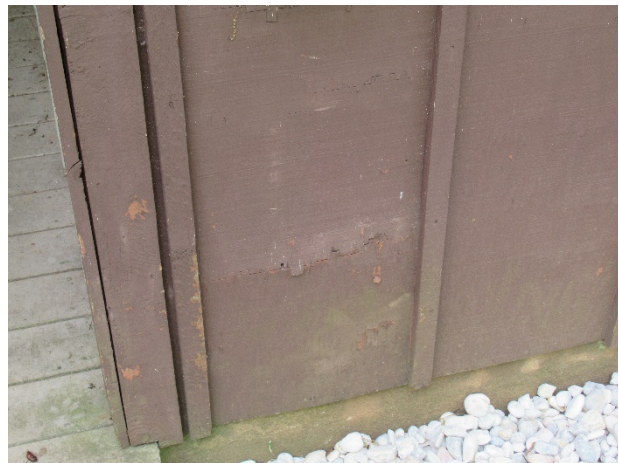
Wood siding finish deterioration

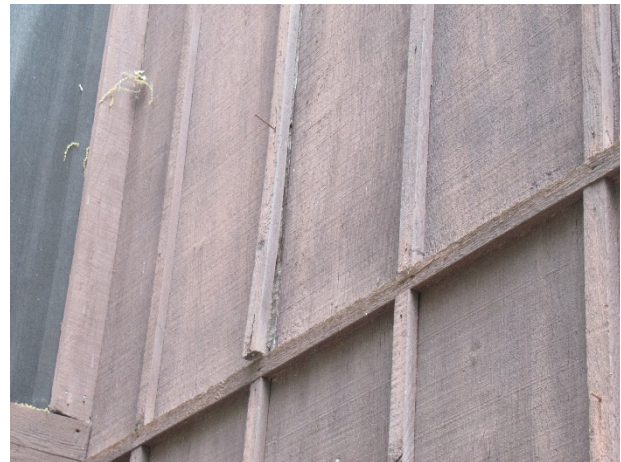
Condition: Fair overall with loose pieces evident

Loose trim

Useful Life: 35- to 40-years. This useful life is dependent upon timely paint applications and partial replacements of deteriorated siding.

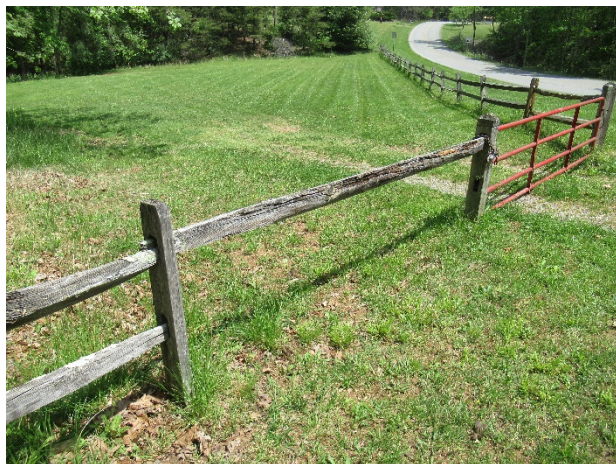
Condition: Good to fair overall condition with missing rails and replaced sections evident

Missing rail

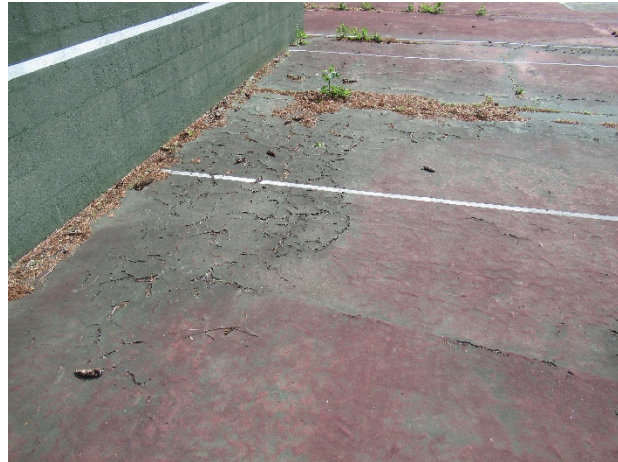
Condition: Poor overall with cracks, deterioration and evidence of standing water

Cracks and deterioration

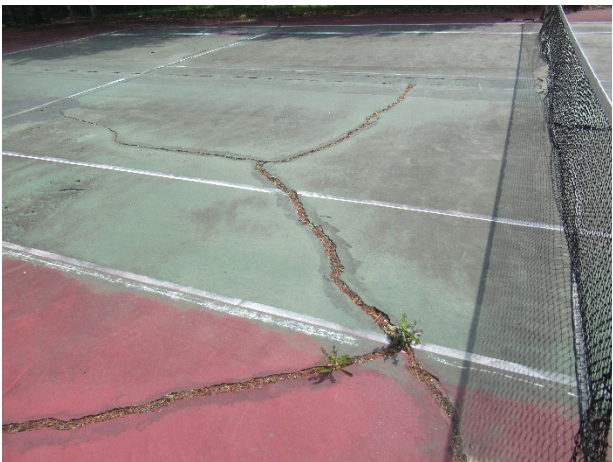
Cracks

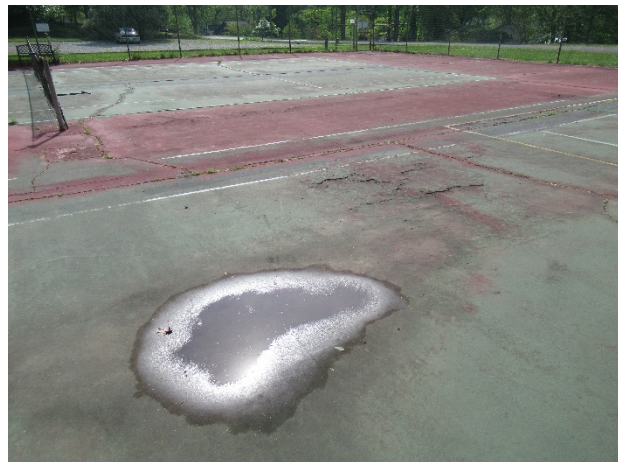
Cracks and evidence of standing water

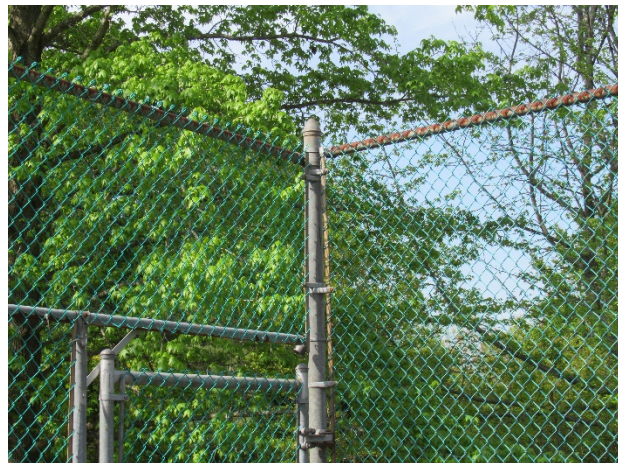
Condition: Fair overall with rust evident

Rust at fence

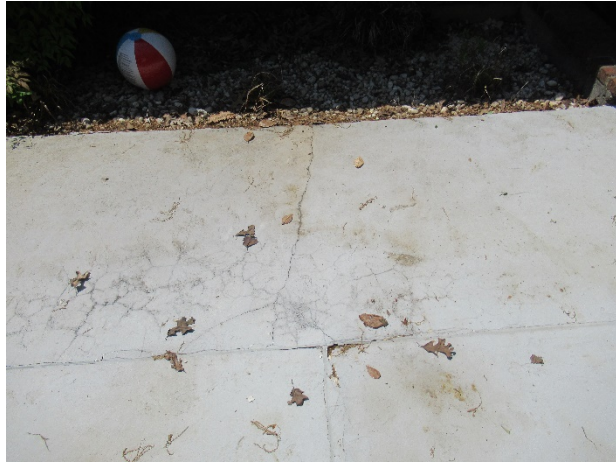
Condition: Good to fair condition with cracks evident

Concrete deck cracks

Useful Life: The useful life of a concrete pool deck is up to 60 years or more with timely repairs. We recommend the Association conduct inspections, partial replacements and repairs to the deck every 8- to 12-years.

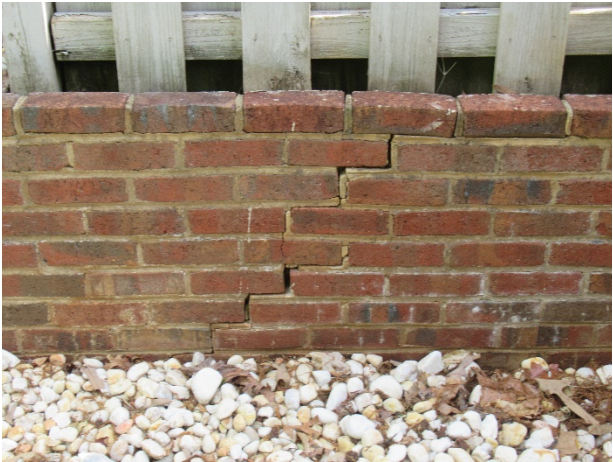
Condition: Good to fair overall with step cracks and efflorescence evident

Masonry retaining wall step cracks

Useful Life: Masonry retaining walls have indeterminate useful lives. However, we recommend the Association plan for inspections and capital repairs every 10- to 15-years to forestall deterioration.

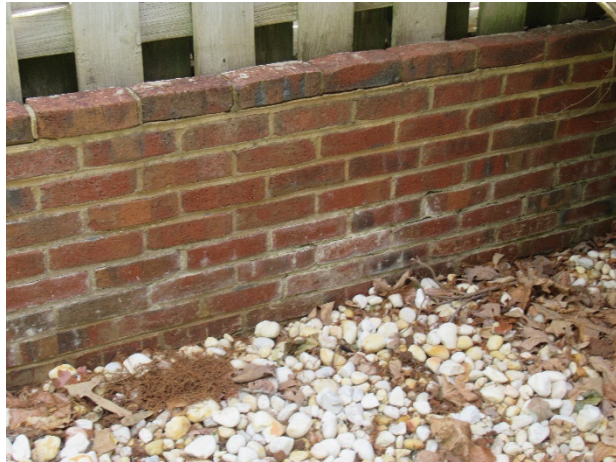
Efflorescence
