FULL RESERVE STUDY

Beechwood Shores Homeowners Association

Moneta, Virginia

May 4, 2021

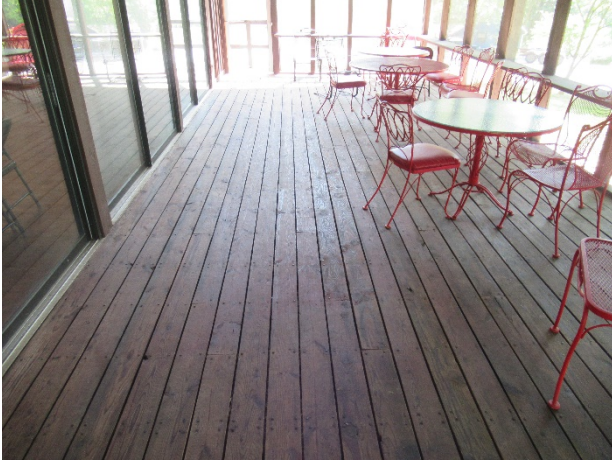
Condition: The decks are in good to fair overall condition with warped components evident. The screens are in good to fair overall condition

Wood deck overview at southeast elevation

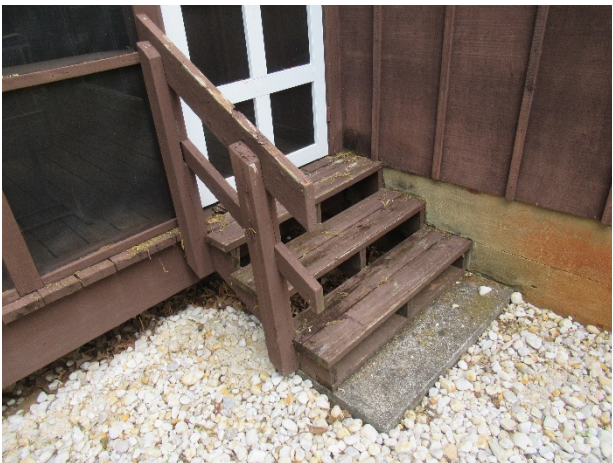
Stairs with railing at southeast deck

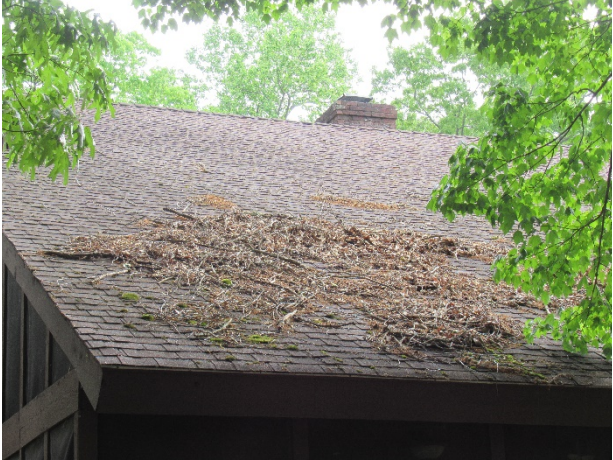
Condition: Fair to poor overall with shingle lift and organic growth shingles evident from our visual inspection from the ground. The Board does not report a history of leaks.

Clubhouse roof overview

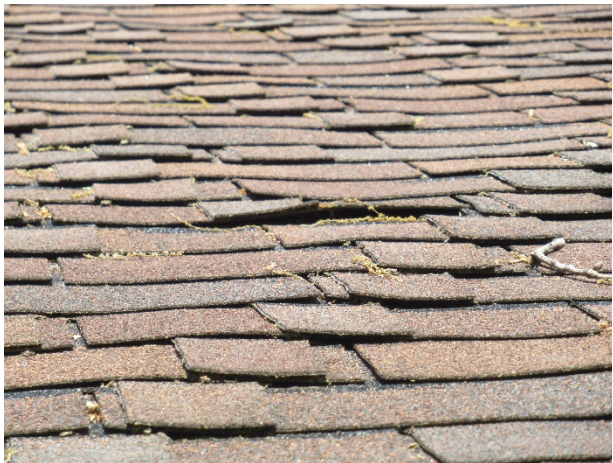
Clubhouse roof shingle lift and organic growth

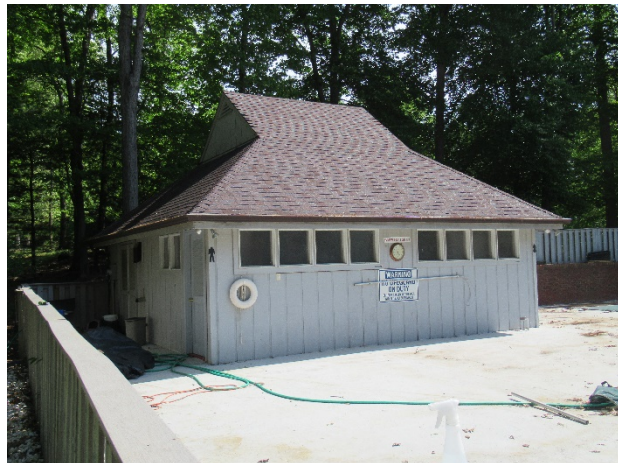
Pool house roof overview

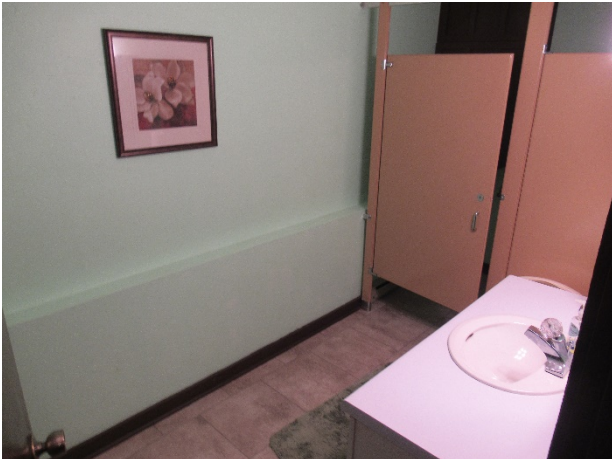
Condition: Fair overall

Rest room overview

Expenditure Detail Notes: Expenditure timing and costs are depicted in the **Reserve Expenditures** table in Section 3. Our cost for renovation includes replacement of the tile floor coverings, wall coverings, paint applications to the ceilings and replacement of the plumbing and light fixtures.

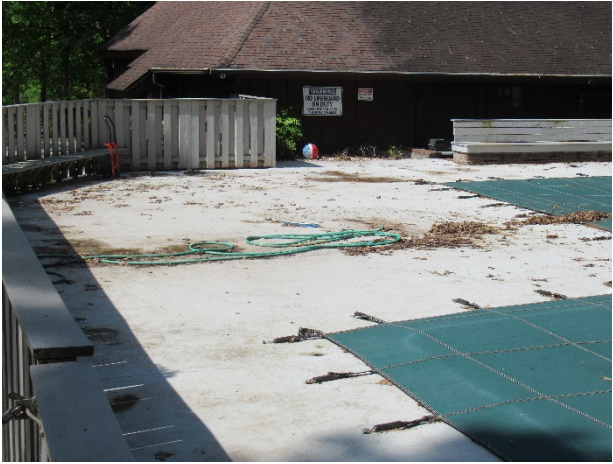
Condition: Good to fair condition with cracks evident

Concrete deck overview

Expenditure Detail Notes: Expenditure timing and costs are depicted in the **Reserve Expenditures** table in Section 3. We recommend the Association budget for the following per event:

- Selective cut out and replacements of up to ten percent (10%) of concrete
- Application of textured coating
- Crack repairs as needed
- Mortar joint repairs
- Caulk replacement

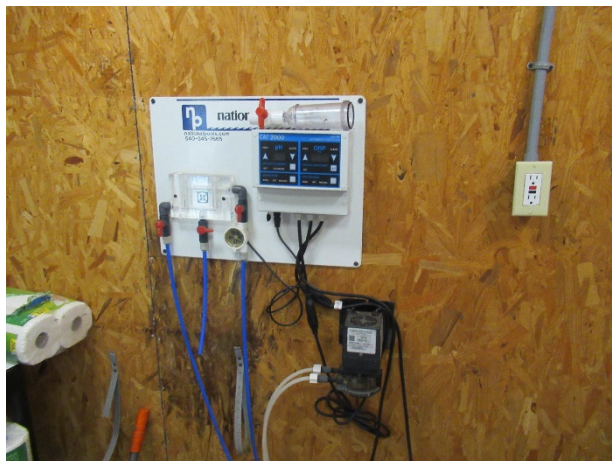
Condition: Reported satisfactory

Mechanical equipment overview

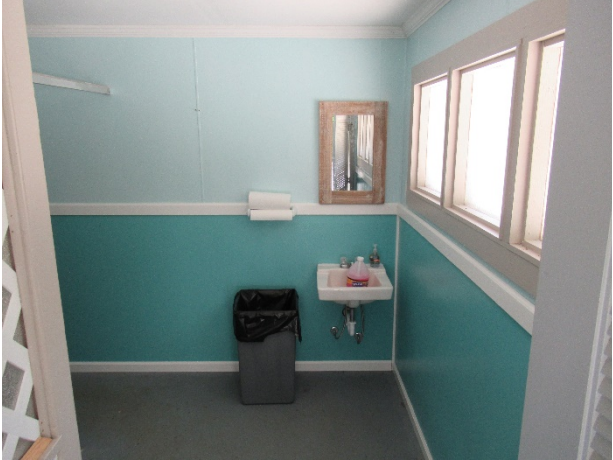
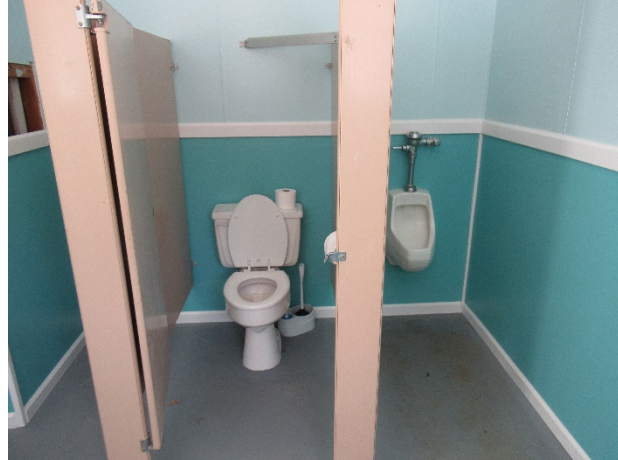
Condition: Good overall

Rest room overview

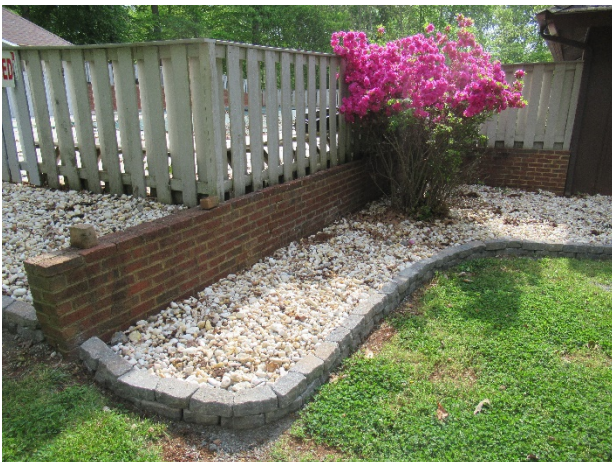
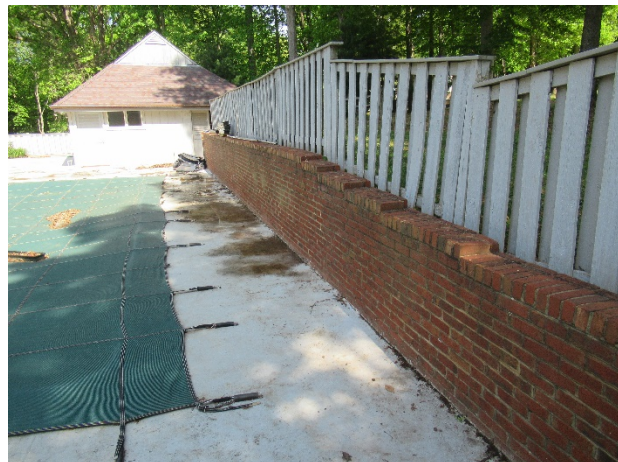
Condition: Good to fair overall with step cracks and efflorescence evident

Masonry retaining wall overview
