FULL RESERVE STUDY

Beechwood Shores Homeowners Association

Moneta, Virginia

May 4, 2021

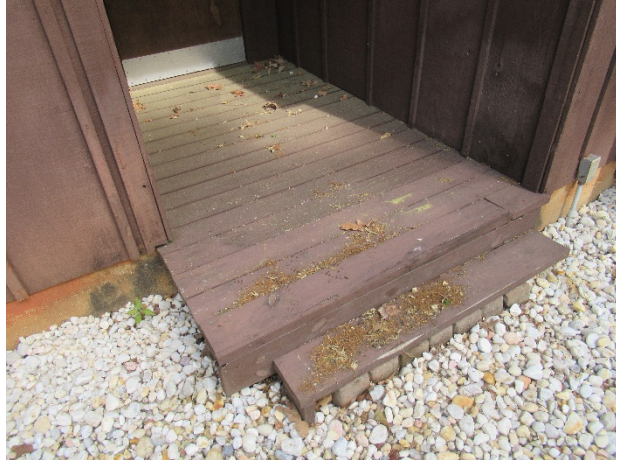
Wood deck overview at southwest entrance

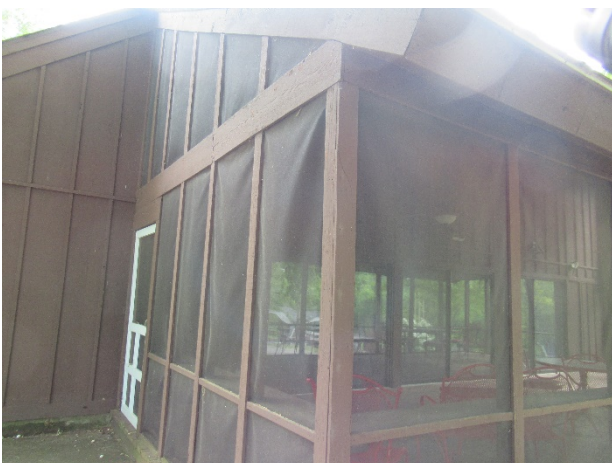
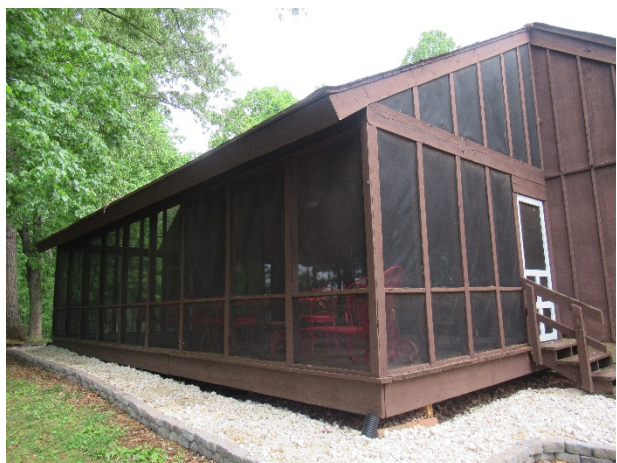
Screen overview

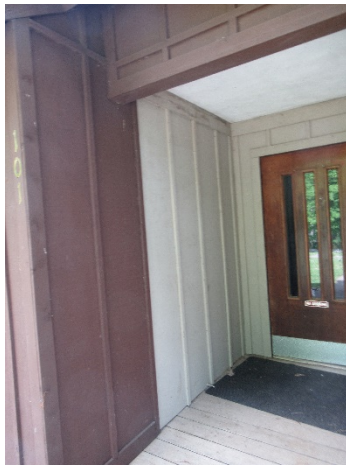
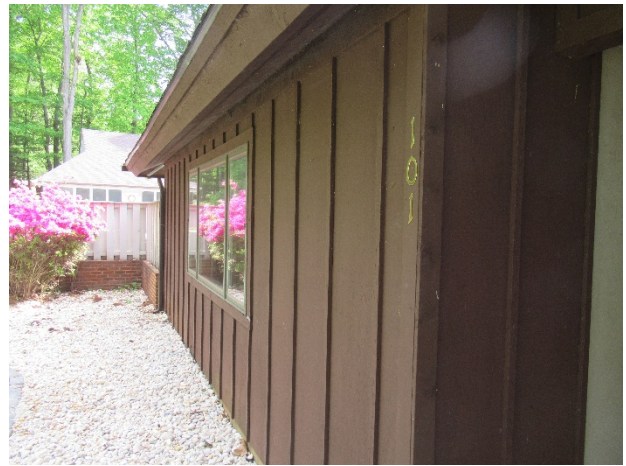
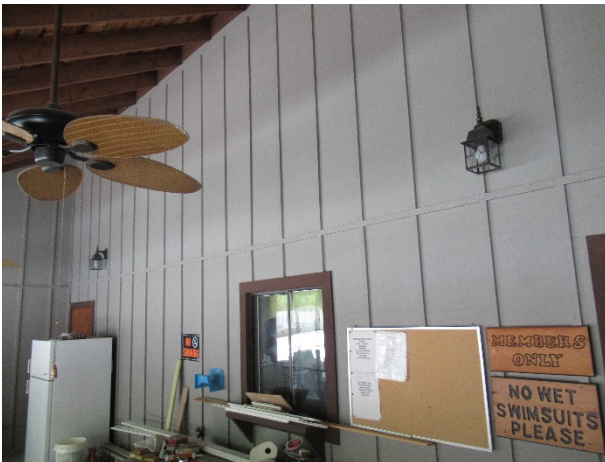
Condition: Fair overall with loose pieces evident

Siding overview

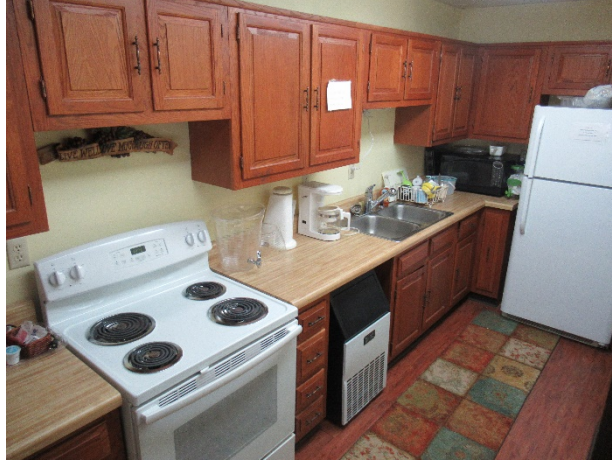
Condition: Fair overall

Kitchen overview

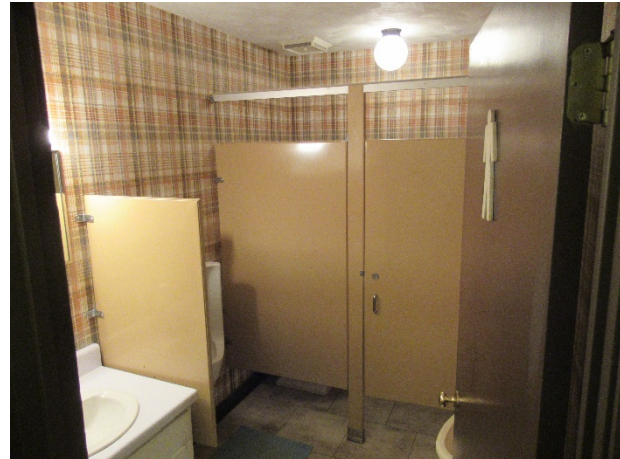
Condition: Fair overall

Rest room overview

Expenditure Detail Notes: Expenditure timing and costs are depicted in the **Reserve Expenditures** table in Section 3. Our cost for renovation includes replacement of the tile floor coverings, wall coverings, paint applications to the ceilings and replacement of the plumbing and light fixtures.

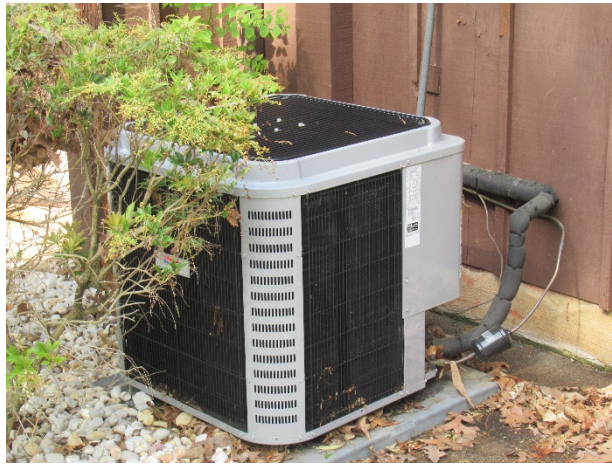
Condition: Reported satisfactory without operational deficiencies

Split system overview

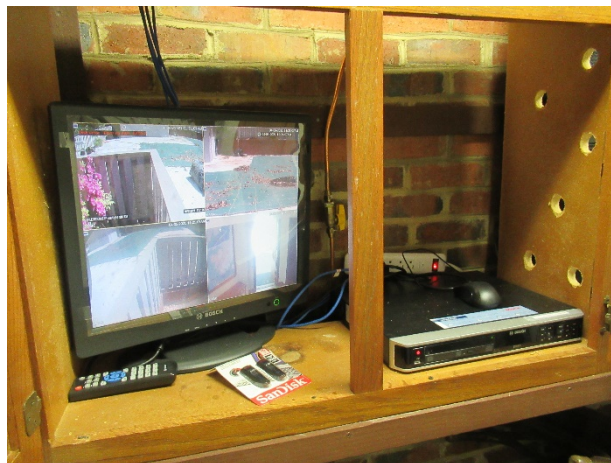
Condition: Reported satisfactory

Security system overview

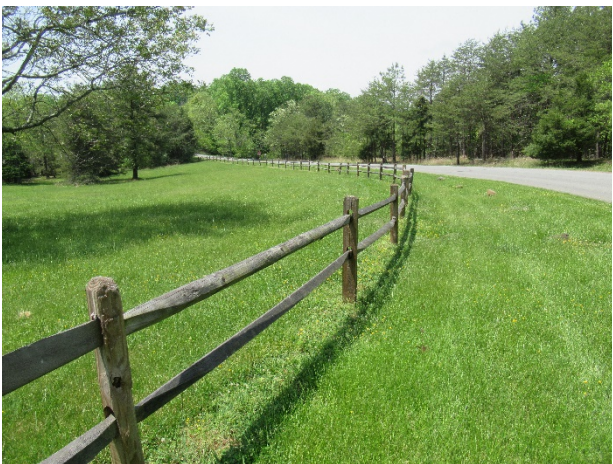
Condition: Good to fair overall condition with missing rails and replaced sections evident

Wood rail fence overview

Expenditure Detail Notes: Expenditure timing and costs are depicted in the **Reserve Expenditures** table in Section 3. The Association should anticipate periodic partial replacements funded through the operating budget due to the non-uniform nature of wood deterioration.

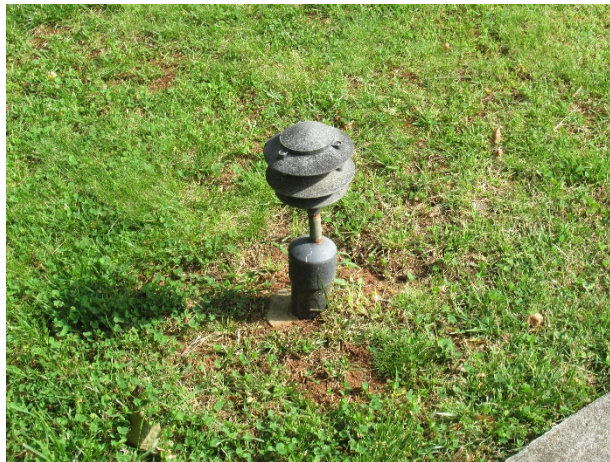
Condition: Fair overall

Light fixture overview

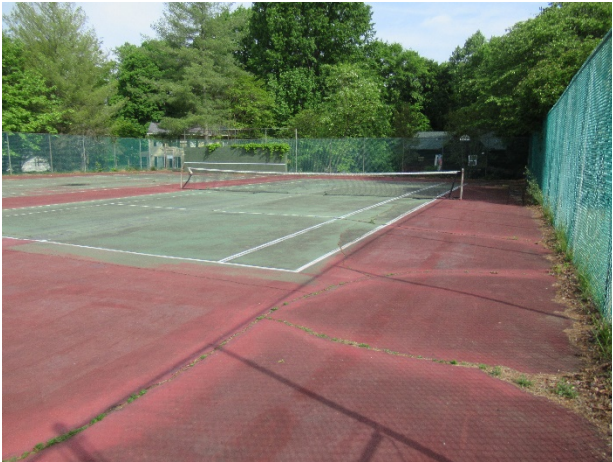
Condition: Poor overall with cracks, deterioration and evidence of standing water

Tennis court and sport court overview

Component Detail Notes: Prior to the application of the color coat, the Association should require the contractor to rout and fill all cracks with hot emulsion. This deters water infiltration and further deterioration of the asphalt playing surface.

Expenditure Detail Notes: Expenditure timing and costs are depicted in the **Reserve Expenditures** table in Section 3. We defer based on other funding priorities, but recommend earlier replacement if funds become available.

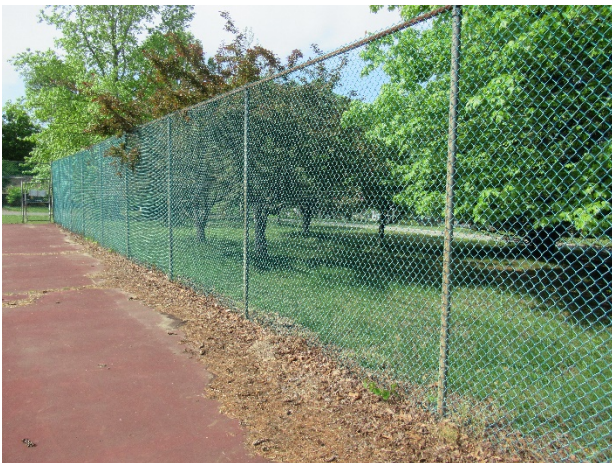
Condition: Fair overall with rust evident

Fence overview

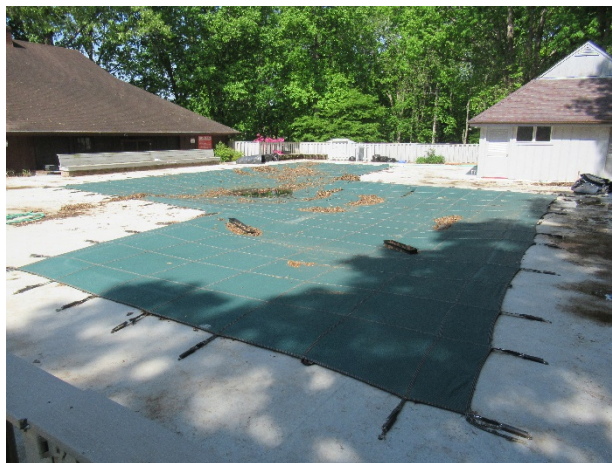
Condition: Fair overall

Pool cover overview

Expenditure Detail Notes: Expenditure timing and costs are depicted in the **Reserve Expenditures** table in Section 3. Based on condition at the time of inspection, we defer replacement of the cover to 2024.

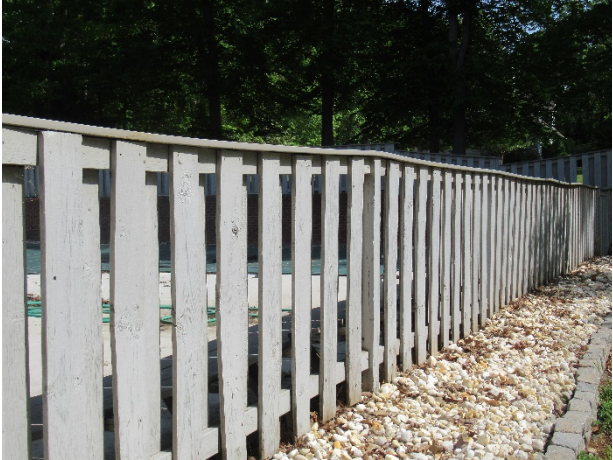
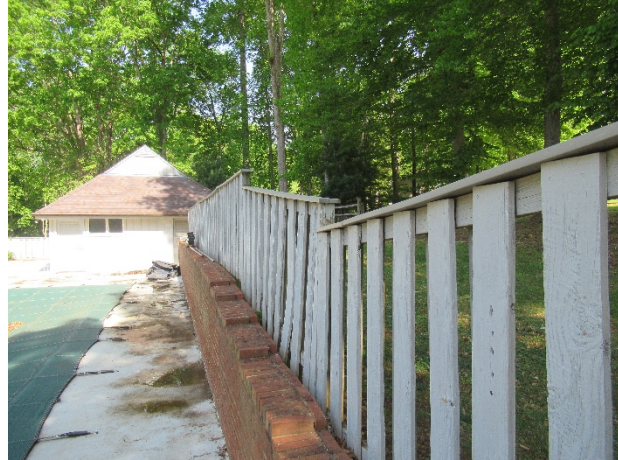
Condition: Good to fair overall condition with leaning sections evident

Wood fence overview

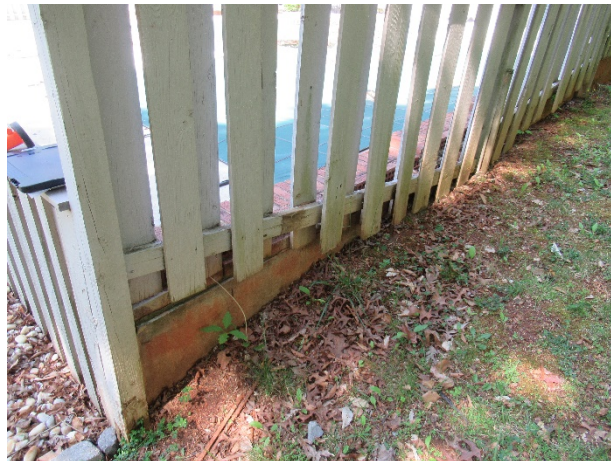
Fence lean

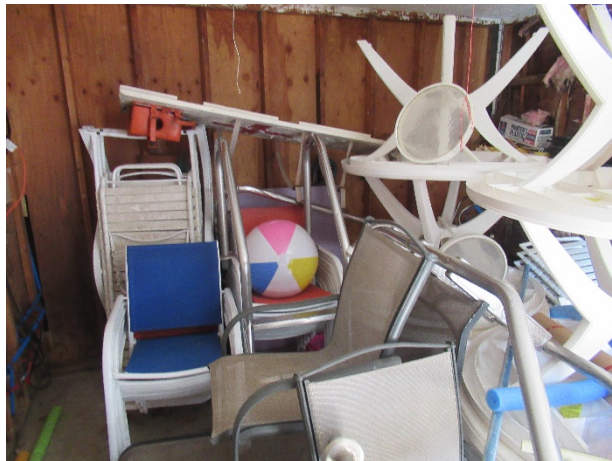
Condition: Good to fair overall

Pool furniture overview
